**CONNECTICUT COASTAL BASIN
EAST LYME, CONNECTICUT**

**GORTON POND DAM
CT. 00157**

**PHASE I INSPECTION REPORT
NATIONAL DAM INSPECTION PROGRAM**

JANUARY, 1981

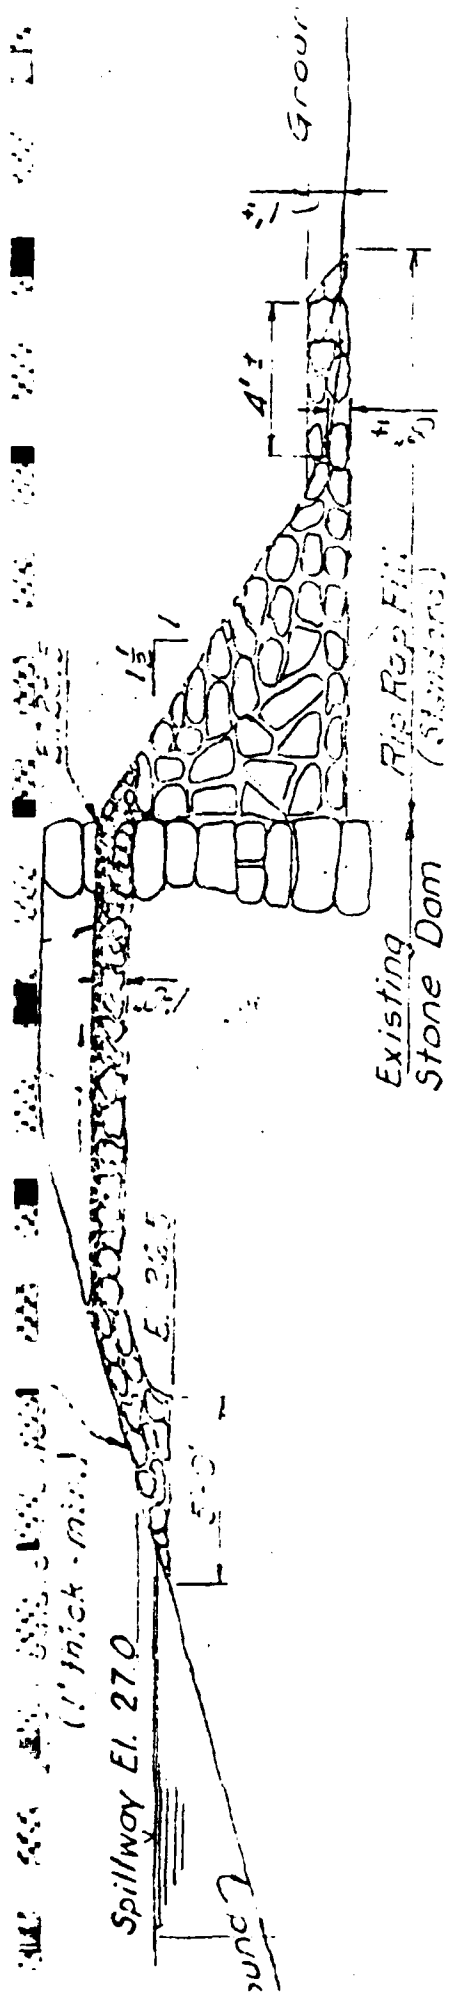
SECTION A-A

- b. Dam. The original dam was an earth embankment with a vertical stone wall on the downstream side. In 1974 a dumped riprap shell was added on the downstream side against the vertical stone wall (See Appendix B-3, Section A-A, and Photo C-2). As a part of the repairs in 1974, the crest and upstream slope were riprapped and crushed stone was used to fill the voids on the crest (Photo C-4).

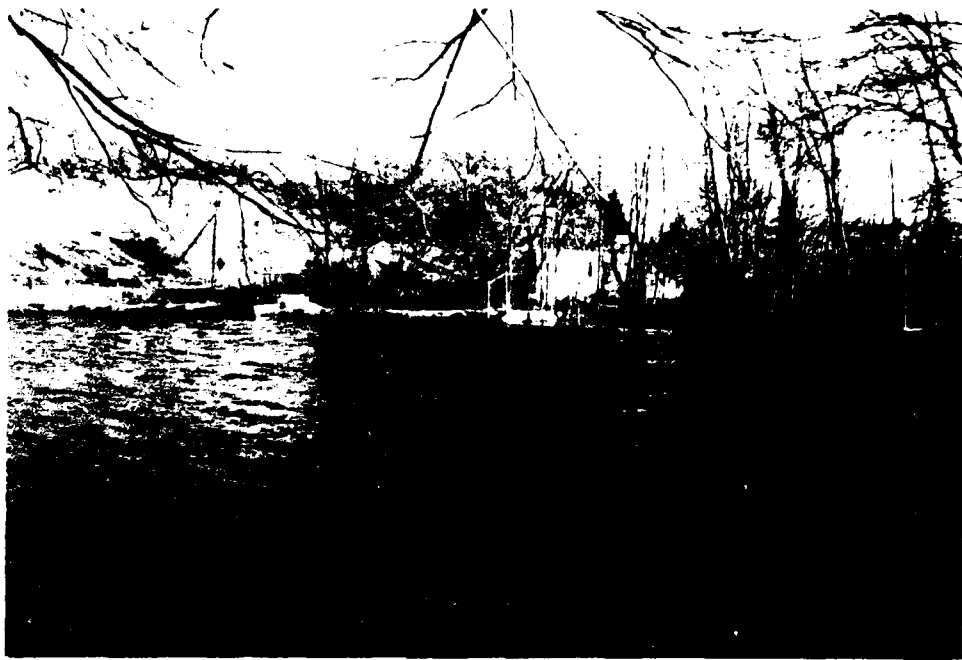
1. Upstream Face. The upstream face of the dam (Photo C-1) is riprap covered with a slope of 2:1. The riprap protection has brush growing through the rock. Some minor erosion has occurred. The right abutment area at the end of the spillway training wall has no riprap protection. The left abutment has incomplete riprap protection. However, there was no significant erosion observed at these locations.

PHOTO C-1: Upstream face of dam from right side.
